An Investigation of Rock Fall and Pore Water Pressure using LiDAR in Highway 63 Rock Cuts

An Investigation of Rock Fall and Pore Water Pressure Using LIDAR in Highway 63 Rock Cuts

**NUTC
R364**

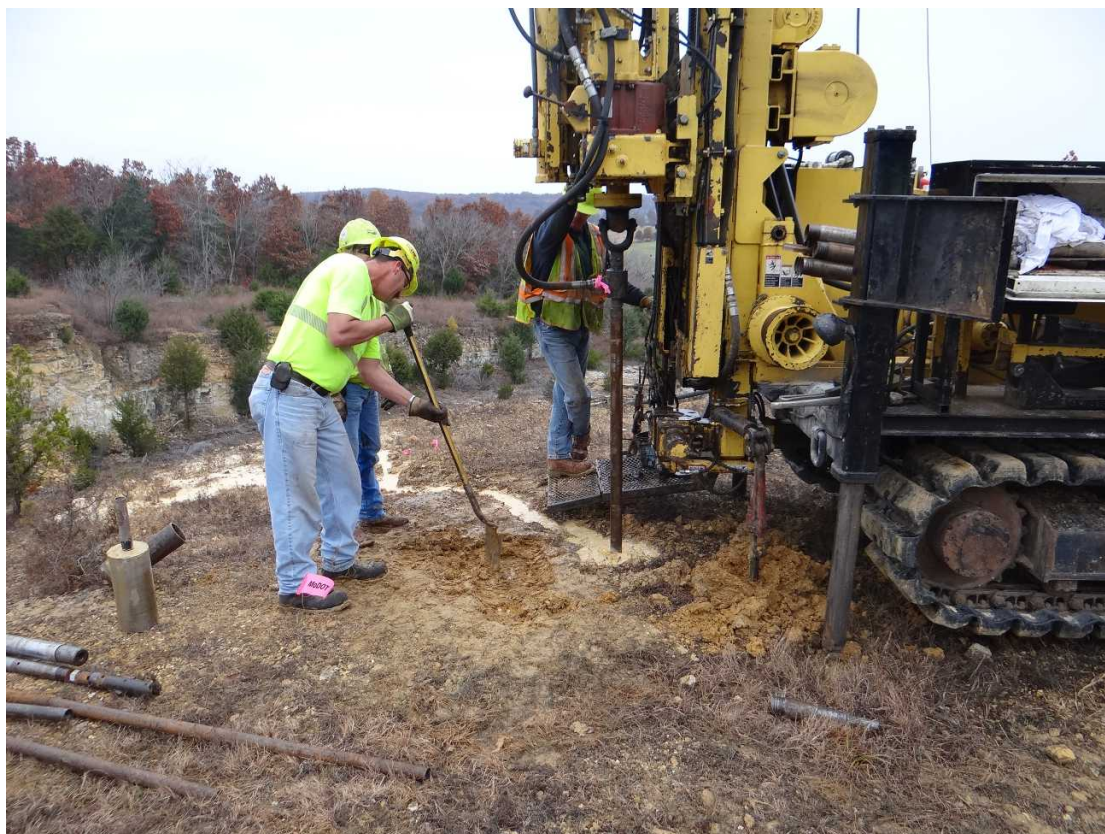
Figure 4 shows the drilling work. On site one, 3 holes were to depths of 22, 45, and 70 feet. On site 3 holes were drilled to depths of 14 and 25'. Details are given in table 1. Although not necessary, drilling in the rock was conducted using a coring bit and double tube core barrel. Figure 5 shows some of the core in the core boxes. Rudimentary core logs can be found in Appendix 1.

Figure 4: Core drilling on site 2.

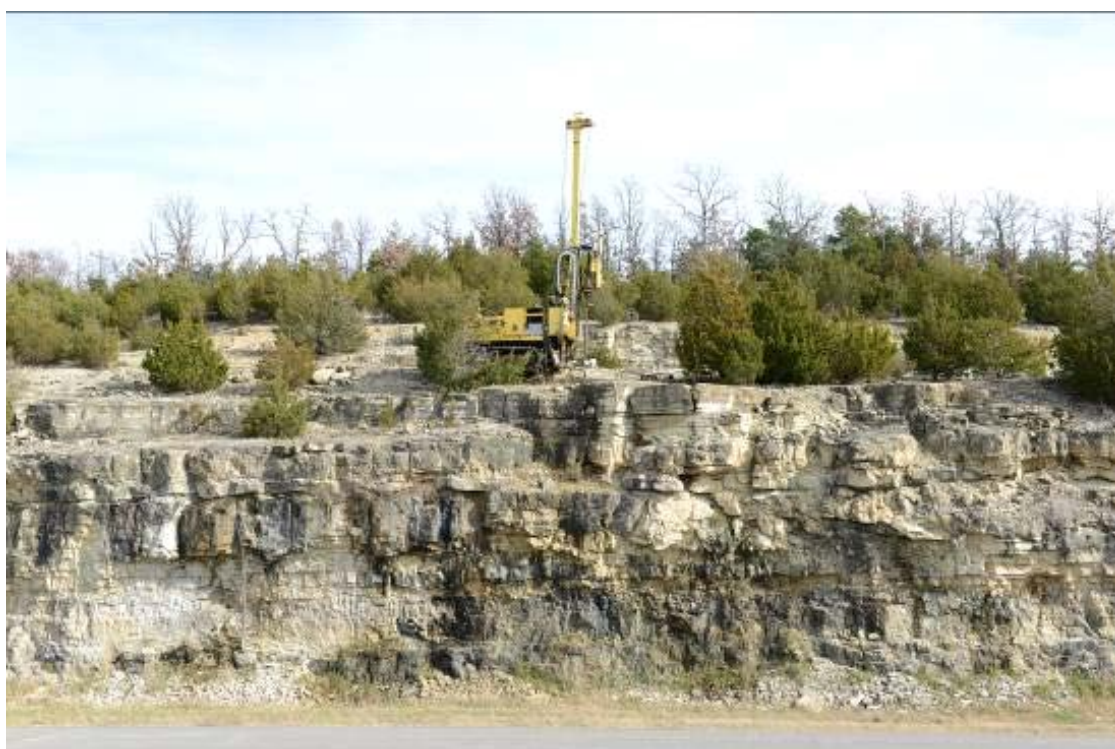
Figure 5: Core drilling on site 1.

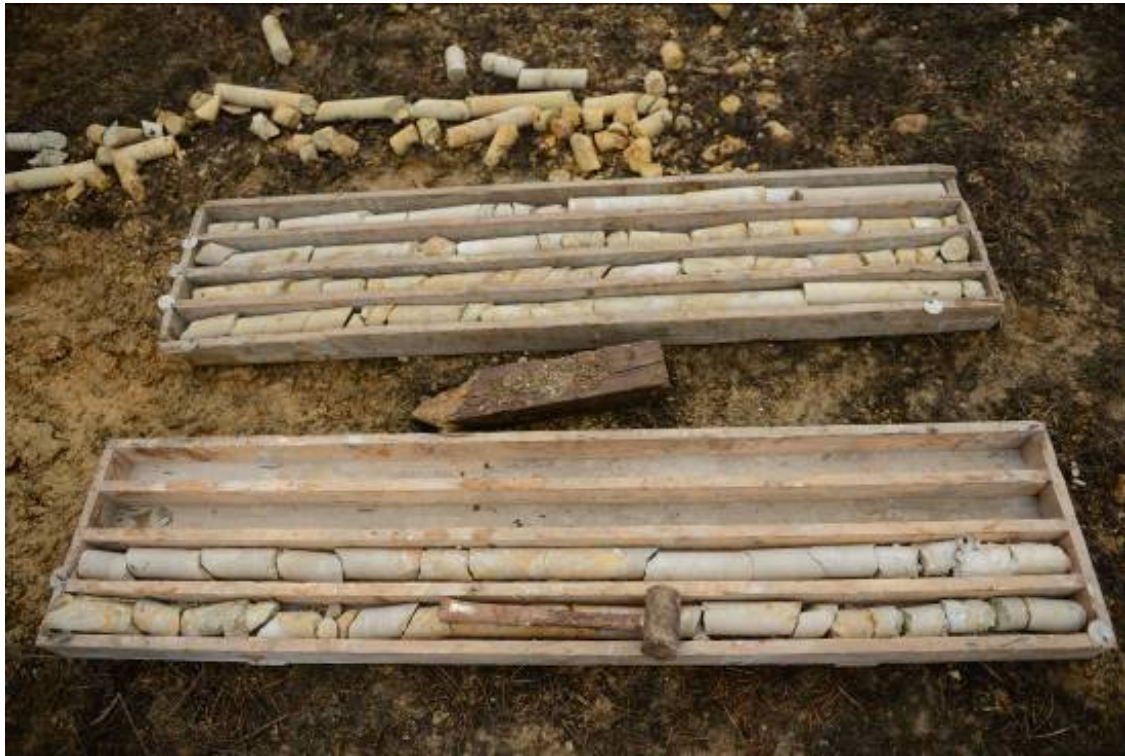
Figure 5: The rock core from Site 1.

0.4-5.4	13:55-14:05	5.0/5.0	0	46.78%	Main rock type is dolomitic. The color is from light grey to tan, highly weathered and highly fractured. There also some sandstone and clay seams. These sandstone seams and clay stone were found at depths of: 2ft, 5.5ft, 9ft, 11ft, 12.5ft, 15.4ft, 28ft, 31.5ft, 32.5ft, 33ft, 43ft, 48.5ft, 53ft, 58.5ft, 69ft.

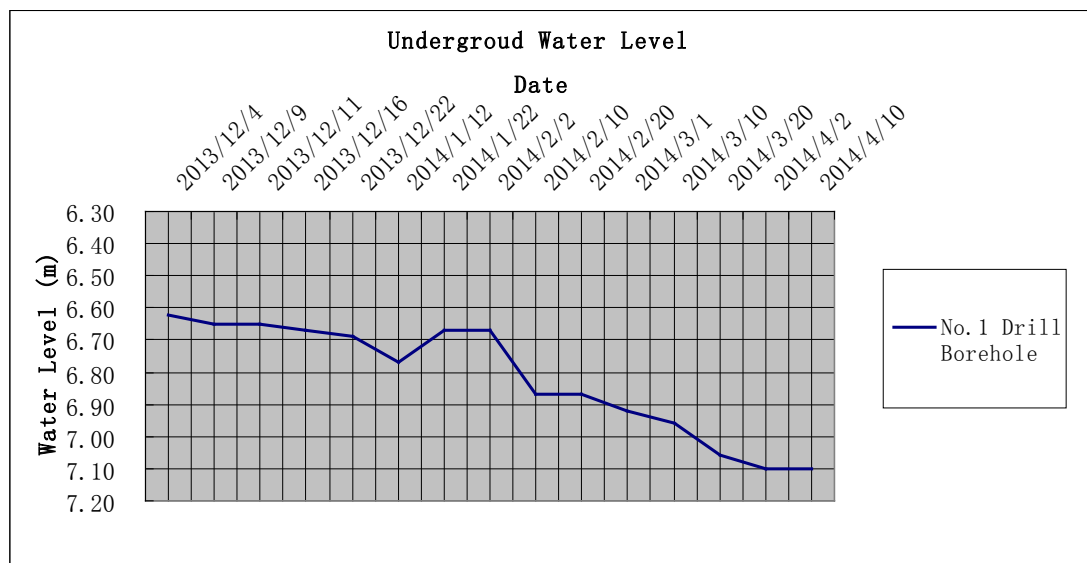
Figure 8: Underground water level in Borehole 1.

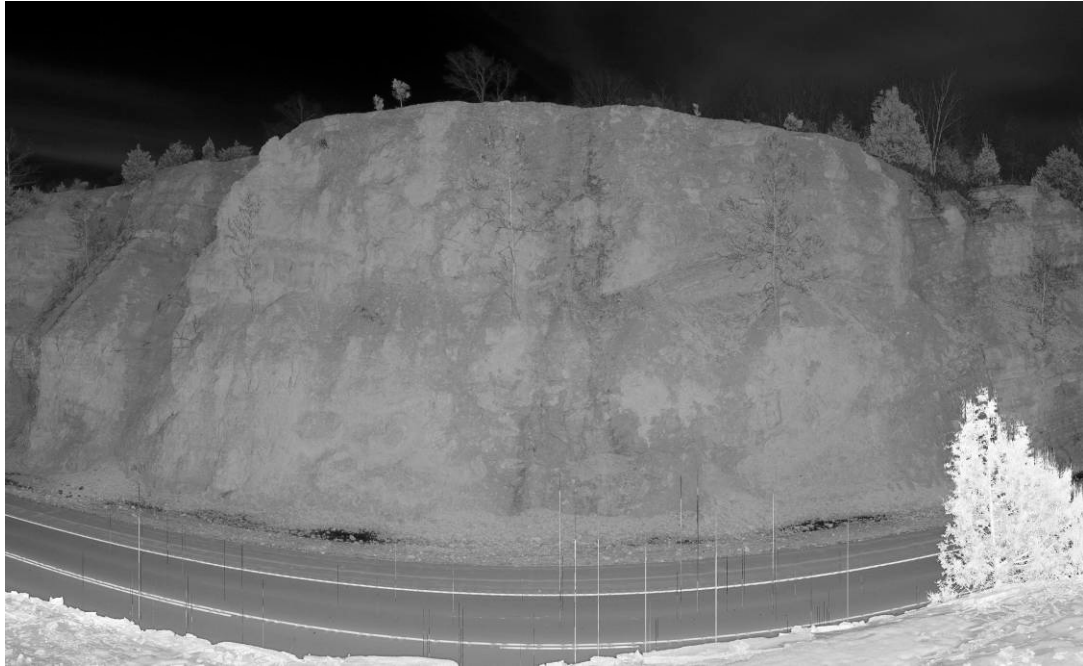
Figure 13 shows the results of a completed scan of the entire cut. Figure 14 shows the results of a completed scan of 2/22/14, right hand side of the cut, cropped to the active face.

Figure 13: Scanning result. Vertical lines show when the scanner intercepted cars speeding done the highway. These are easily edited out.
